# Intel® StrongARM®\* SA-1110 Microprocessor

Specification Update

*April 2001*

Order Number: 278259-022

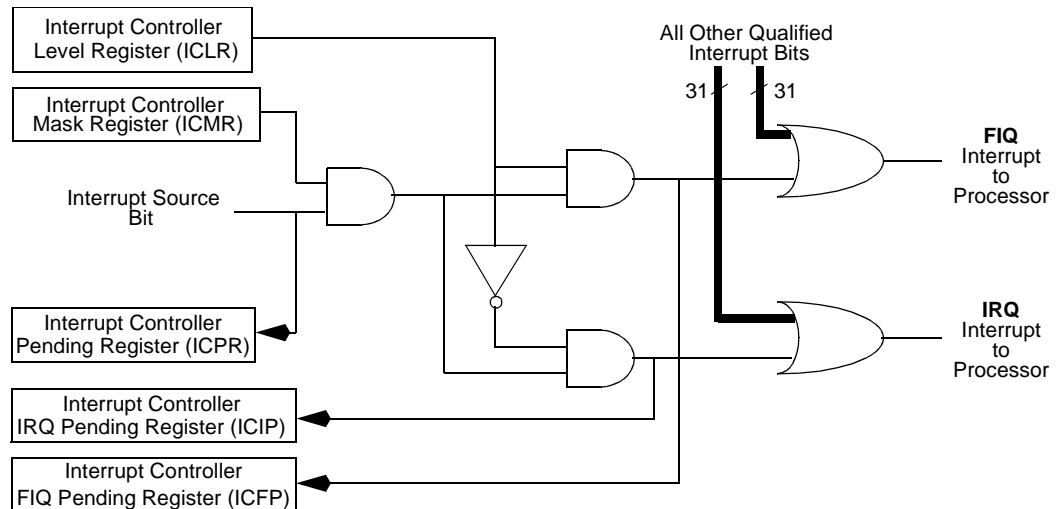
**Figure 9-2. Interrupt Controller Block Diagram**

Figure 9-2 now appears as:

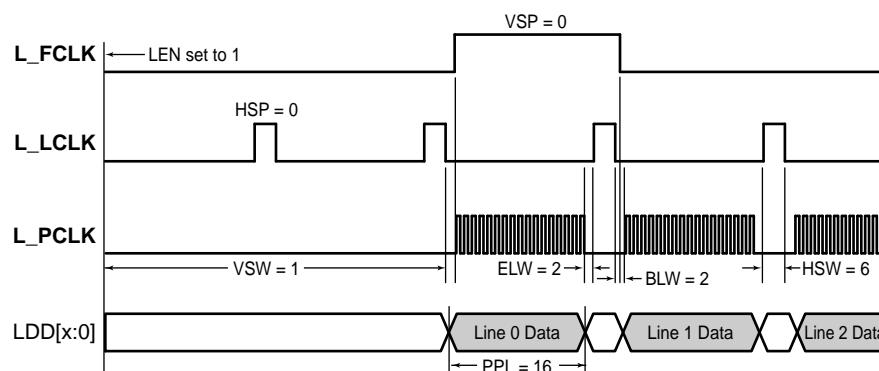
Figure 11-10. Passive Mode Beginning-of-Frame Timing

Changed the Notes: in Figure 11-10 to show the range of HSW as 1 to 64, not 0 to 64. The corrected figure is shown below:

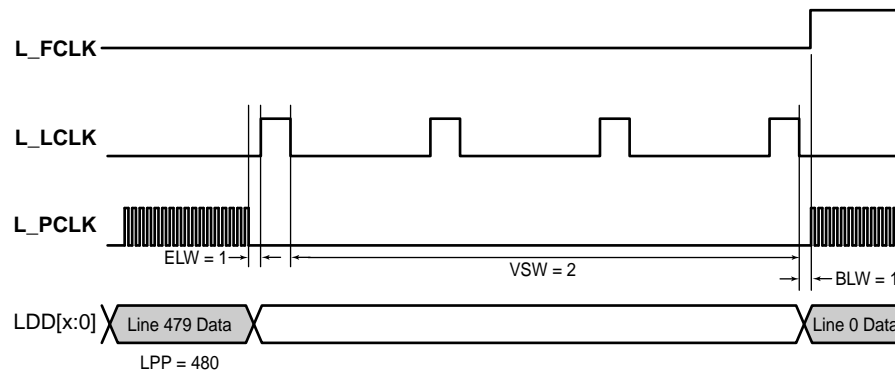
Figure 11-11. Passive Mode End of Frame Timing

Also, changed the Notes: in Figure 11-11 to show the range of BLW as 1 to 256, not 0 to 256. The corrected figure is shown below:

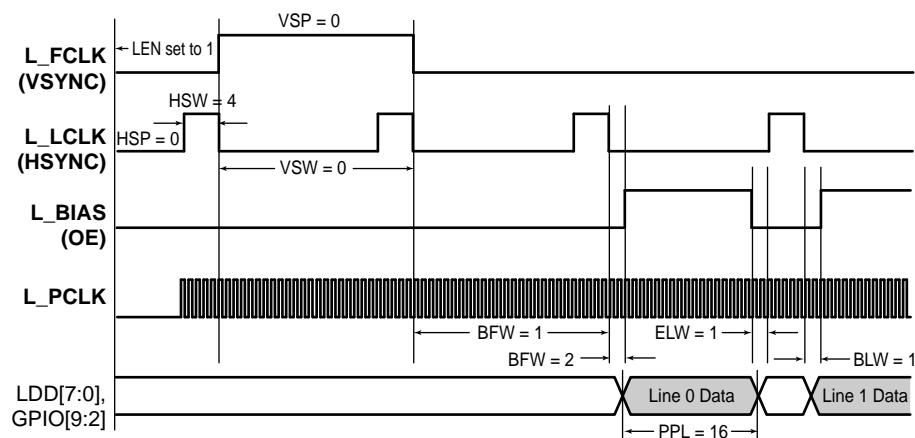
Figure 11-13. Active Mode Timing

Corrected Notes: in Figure 11-13 to show the range of PPL as 16 to 1024 (not 1 to 1024.) The corrected figure is shown below:
